INDOOR AIR QUALITY ASSESSMENT

**Dr. Fredrick N. Sweetsir Elementary School
104 Church Street
Merrimac, Massachusetts**

Prepared by:
Massachusetts Department of Public Health
Bureau of Environmental Health Assessment
Emergency Response/Indoor Air Quality Program
November 2003

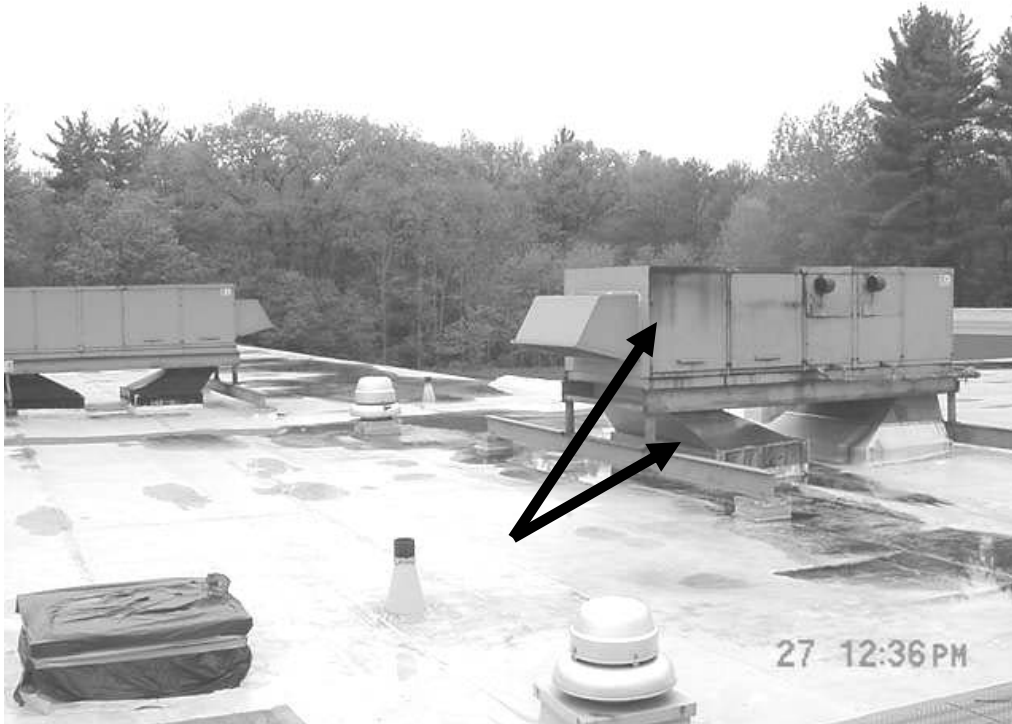
Picture 1

Ventilation is provided by rooftop air handling units (AHUs) (Picture 1). Fresh air is distributed by AHUs via ductwork connected to ceiling-mounted air diffusers and/or diffusers located on cabinets along the interior wall of classrooms (Pictures 2 & 3). The amount of fresh air drawn into AHUs is controlled by an actuator motor that adjusts movable louvers. On the day of the assessment, all AHUs were functioning, however, the louvers on some of the AHUs were closed, limiting airflow (Picture 4). The condition of the AHUs and ductwork appears to be poor. Rooftop AHUs were severely corroded, weathered and/or physically damaged (Pictures 1, 5 & 6). The condition of AHUs is discussed in further detail in the Microbial/Moisture Concerns section of this assessment.

**Rooftop AHUs, Note Dark Stains on Ductwork and Near Top of AHU
Indicating Rust/Corrosion**

1. Based on the age, physical deterioration and availability of parts of the HVAC system, the BEHA strongly recommends that an HVAC engineering firm -fully evaluate the ventilation system.

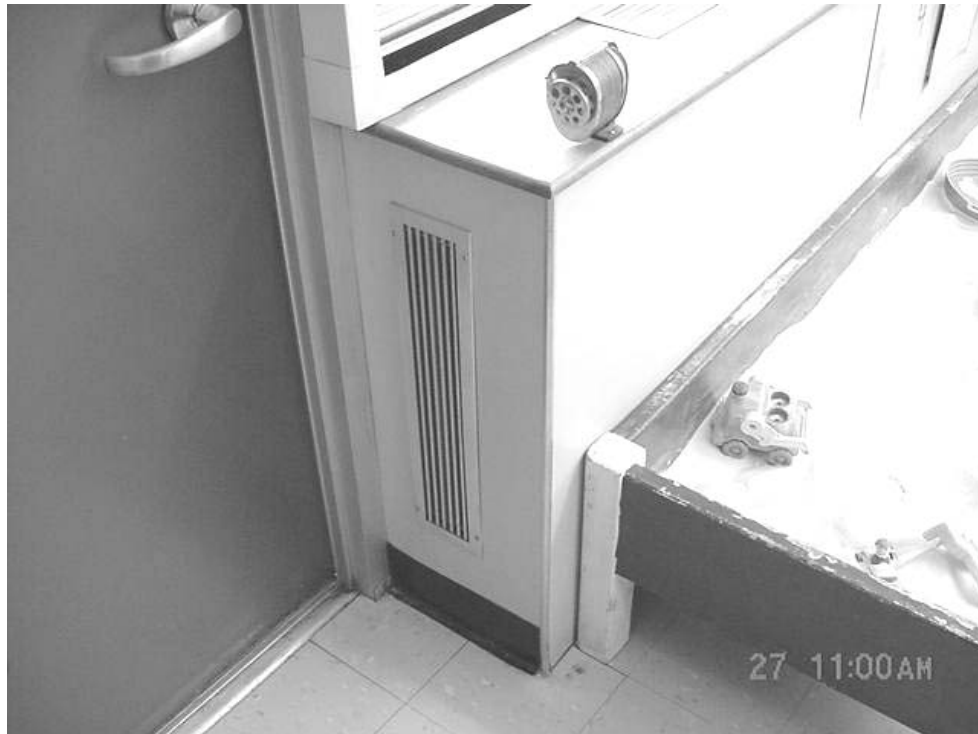
Picture 2

Air Diffuser on Side of Classroom Cabinet

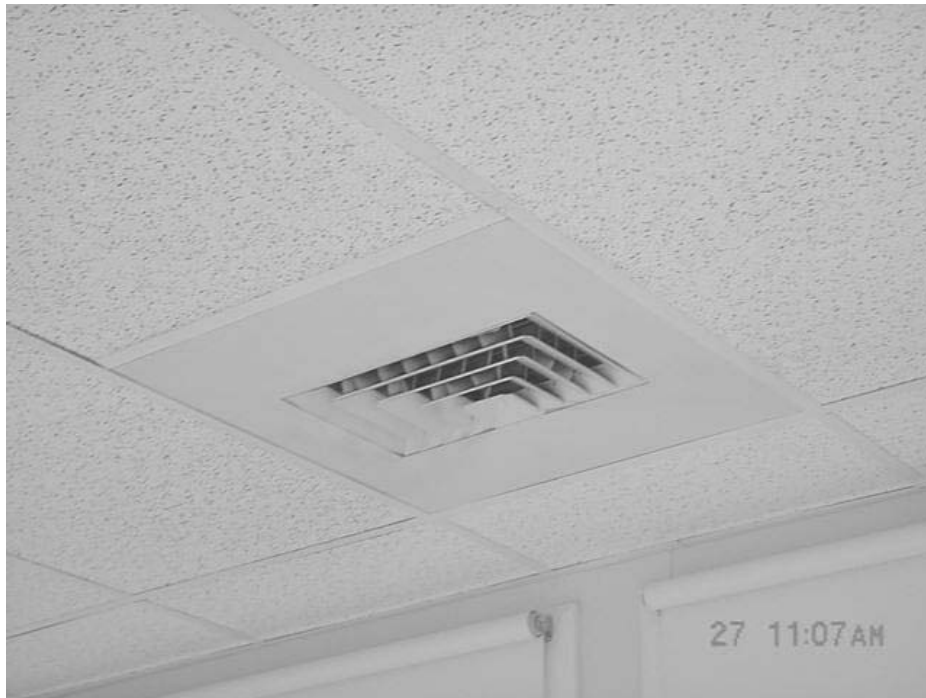
Picture 3

Ceiling-Mounted Air Diffuser

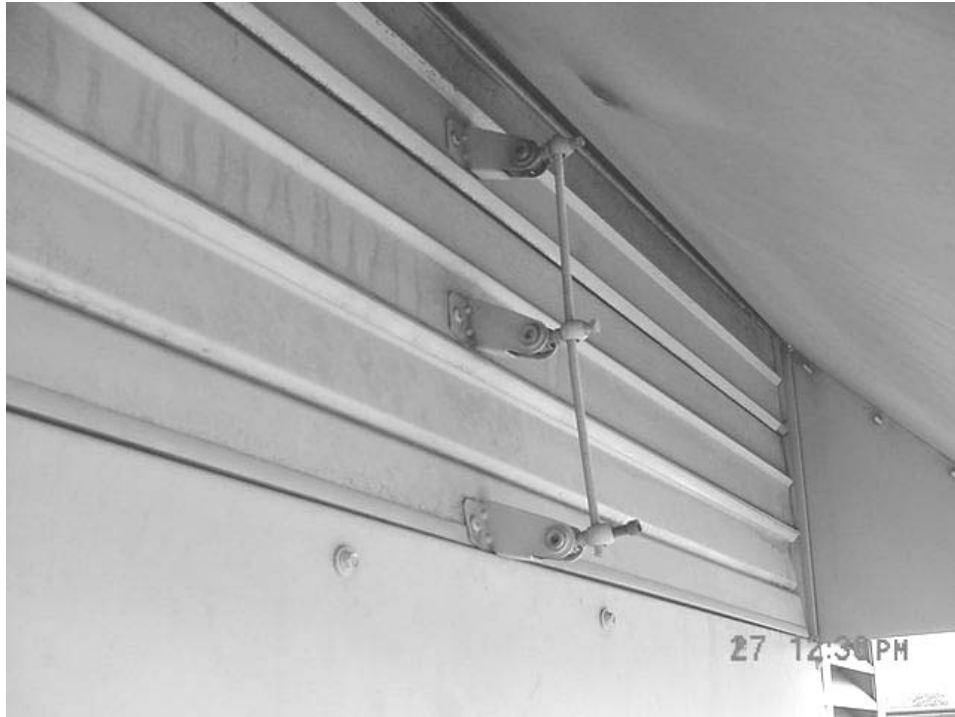
Picture 4

AHU Fresh Air Intake Louvers Shut

3. Consider consulting a heating, ventilation and air conditioning (HVAC) engineer concerning the calibration of fresh air control dampers school-wide.

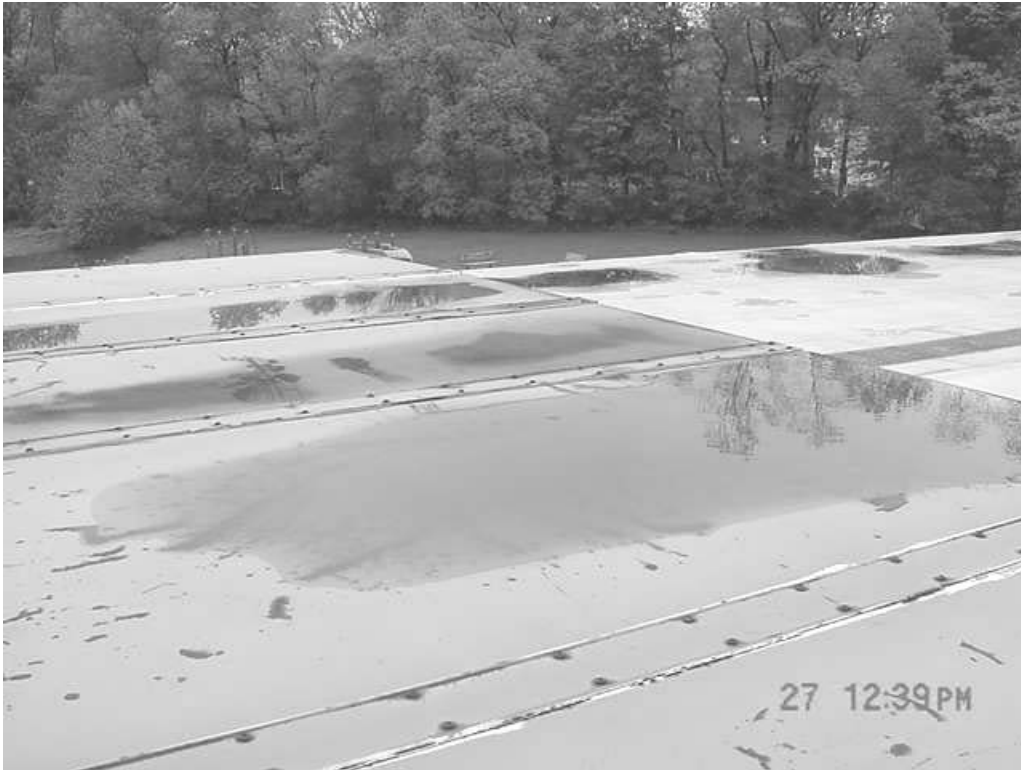
As previously noted, the casings of AHUs were corroded. The top of the AHU in Picture 5 is concave, due to water pooling. The assessment occurred on a day of moderate rainfall. Pooling water was noted on top and seeping down the side of one of the AHUs. The interior of this AHU was examined and found to have standing water due to leakage around metal access panels in the housing (see Picture 6). Accumulated debris (dirt, dust, etc.) and porous insulation material inside the AHU can provide a medium for mold growth when it becomes wet. If these materials become colonized with microbial growth, spores can be distributed to occupied areas via the ventilation system.

Water Pooling/Corrosion on Top of AHU

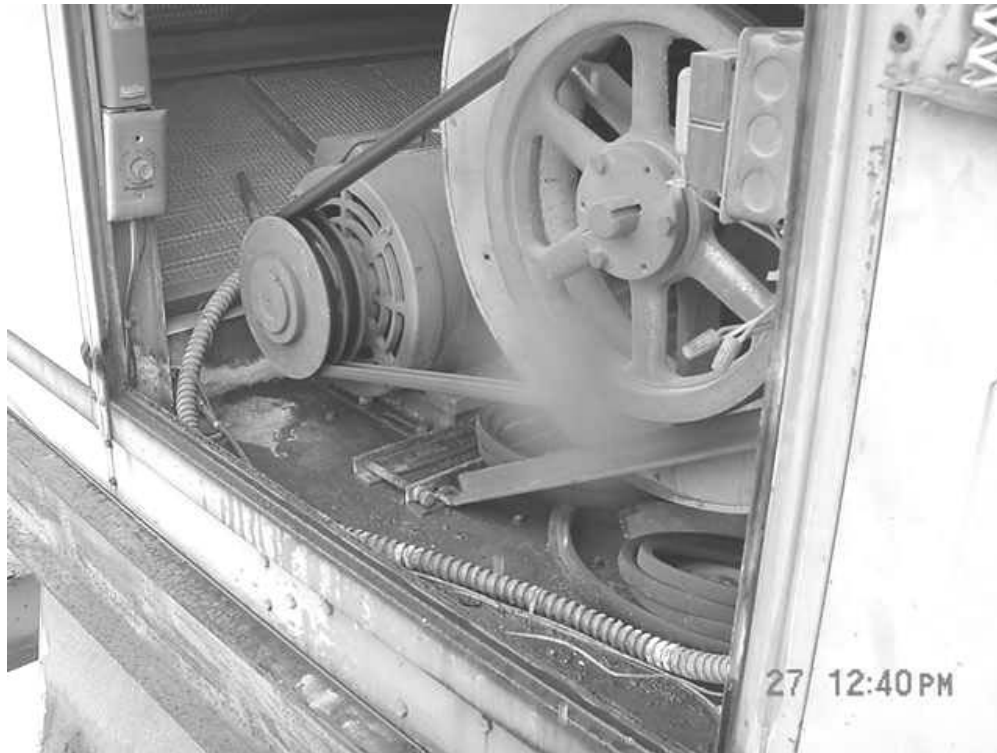
Picture 6

Moisture/Debris on Floor of AHU

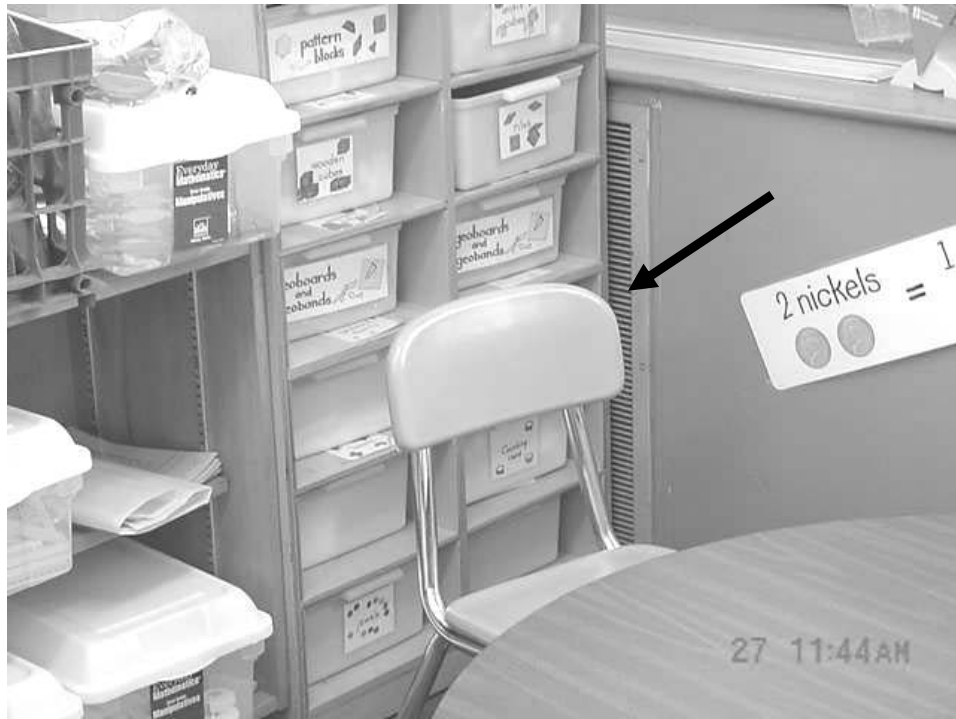
Picture 7

The mechanical exhaust ventilation system consists of ducted ceiling and wall-mounted exhaust vents which return air to the rooftop AHUs. A number of exhaust vents were blocked by desks, cabinets, and other furniture (Picture 7). In order for exhaust ventilation to function as designed, vents must remain free of obstructions. Without proper exhaust ventilation, indoor air pollutants can build up and lead to indoor air quality/comfort complaints.

Wall-Mounted Exhaust Vent Obstructed by Cart

4. Inspect exhaust motors and belts for proper function, repair and replace as necessary.
5. Remove all blockages from supply and exhaust vents.
6. Consider having ventilation systems re-balanced every five years by an HVAC engineering firm.

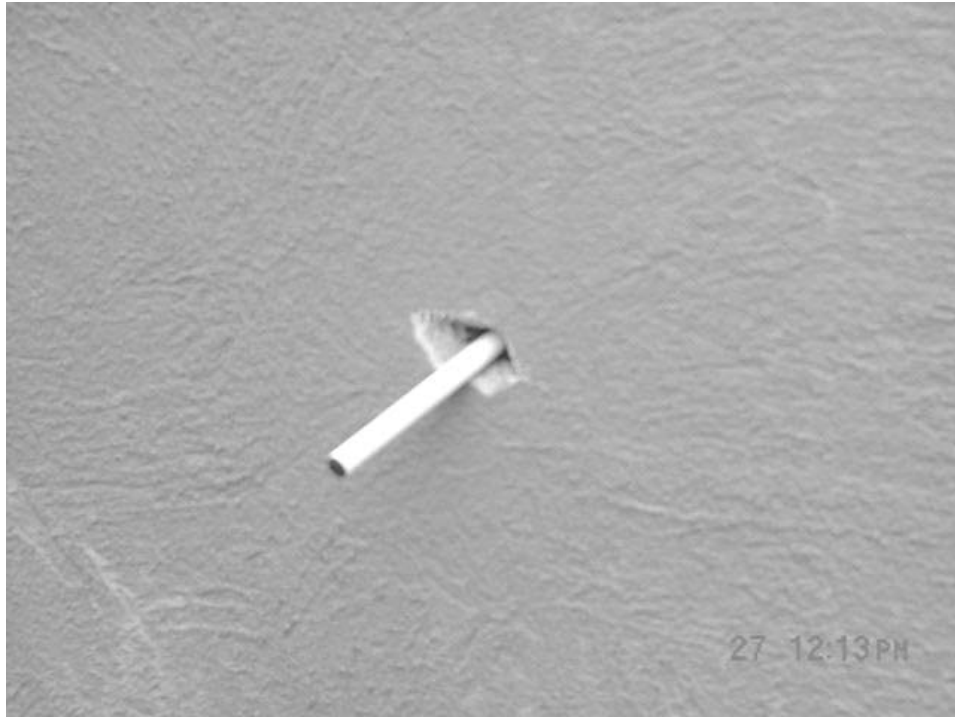
Picture 8

- Holes/cracks were observed in exterior walls (Pictures 8 & 9).
- Caulking around exterior window frames and wall panels was crumbling or missing (Pictures 10 & 11).
- Shrubbery and other plants exist in close proximity to foundation walls (Picture 12).

Hole in Exterior Wall Covering, Pen Inserted to Illustrate Depth of Hole

8. Conduct thorough inspection of the building envelope and repair/replace missing or damaged caulking and seal all cracks and holes in walls to prevent water penetration.

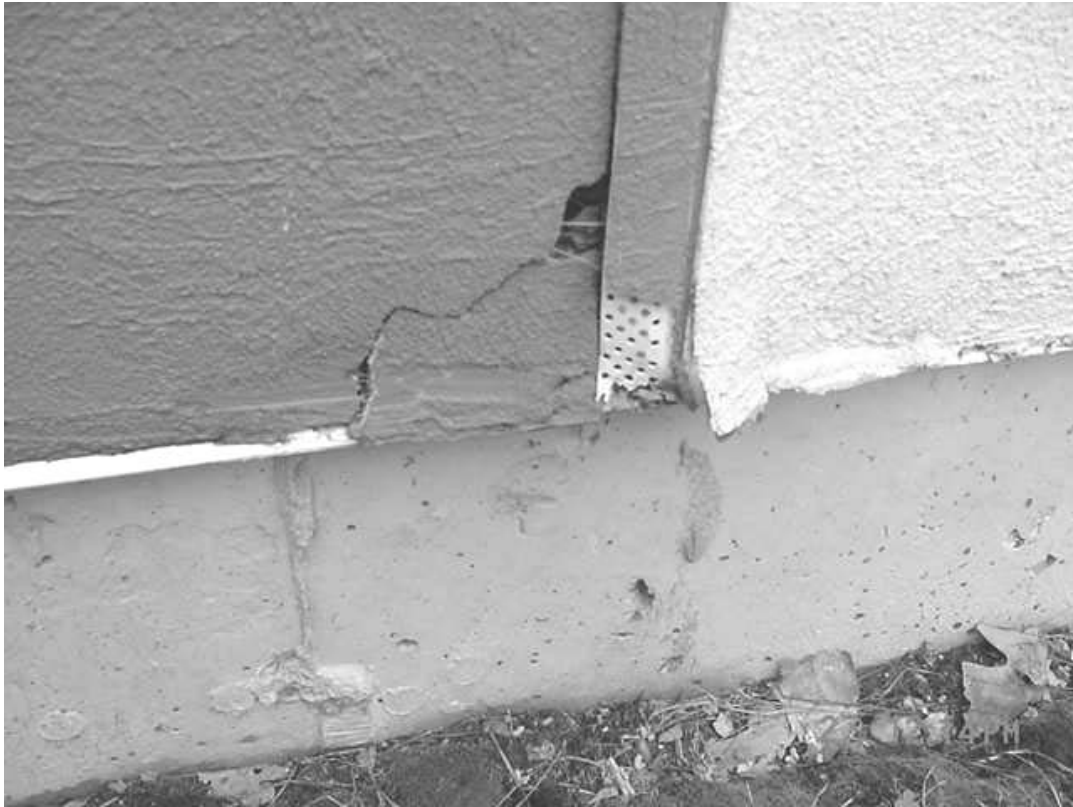
Picture 9

Damaged Wall Material Exposing Interior Matrix

9. Consider having exterior brick re-pointed and waterproofed to prevent water intrusion.
10. Replace/repair damaged downspouts and install elbows in a manner to direct rainwater away from the building.

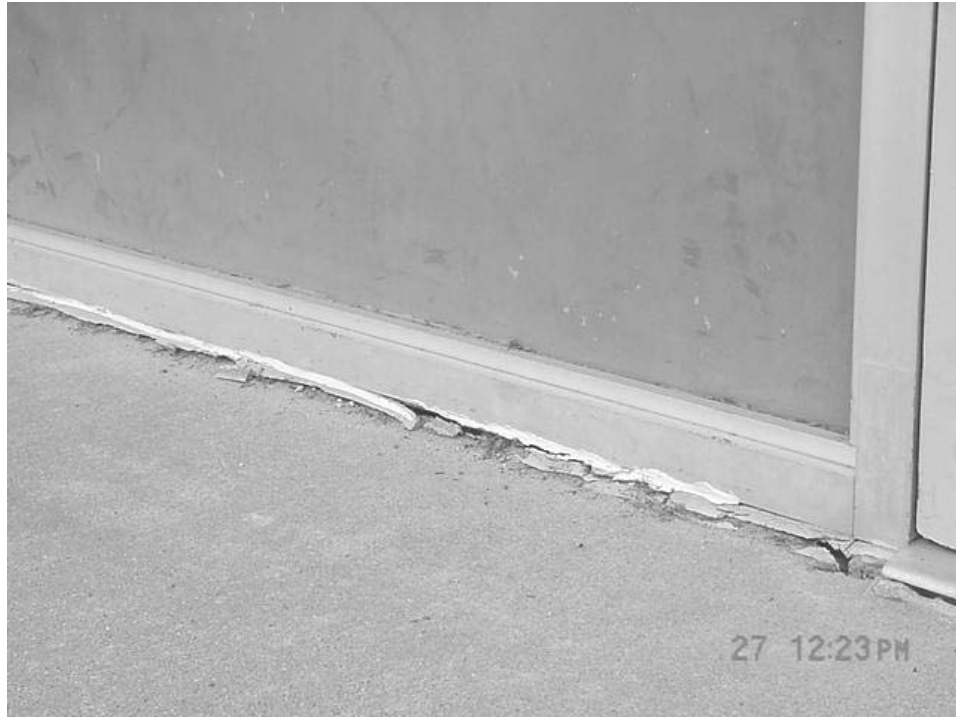
Picture 10

Missing/Damaged Caulking Along Base of Wall Panel

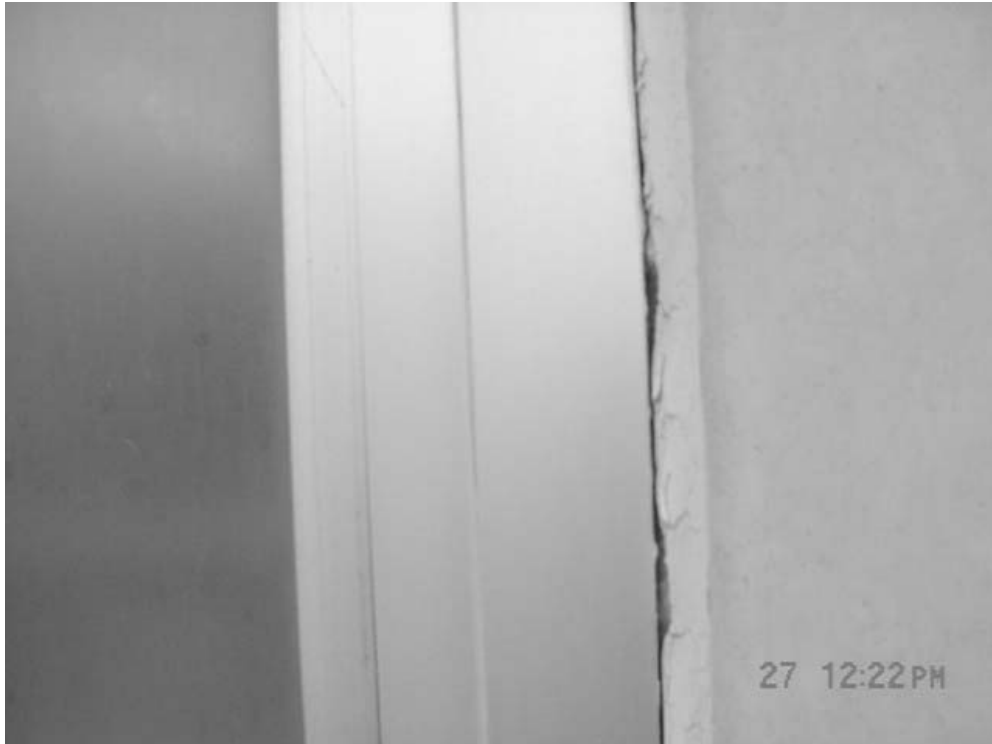
Picture 11

Compromised Caulking around Window Frame

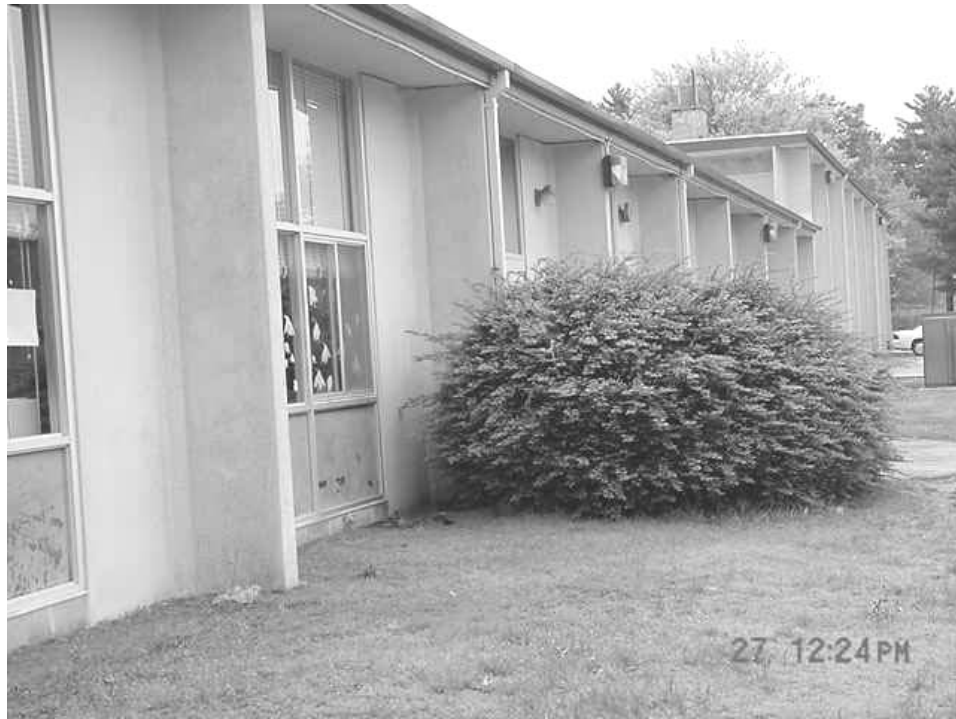
Picture 12

The growth of roots against the exterior walls can bring moisture in contact with wall brick and eventually lead to cracks and/or fissures in the foundation below ground

level. Over time, this process can undermine the integrity of the building envelope and provide a means of water entry into the building through capillary action through foundation concrete and masonry (Lstiburek & Brennan, 2001).

Shrubbery in Close Proximity to Exterior/Foundation Wall

11. Remove accumulated plant debris from roof. Inspect roof drains regularly for proper drainage.
12. Remove plant growths against the exterior wall/foundation of the building to prevent water penetration. Trim trees in rear of building away from brickwork.

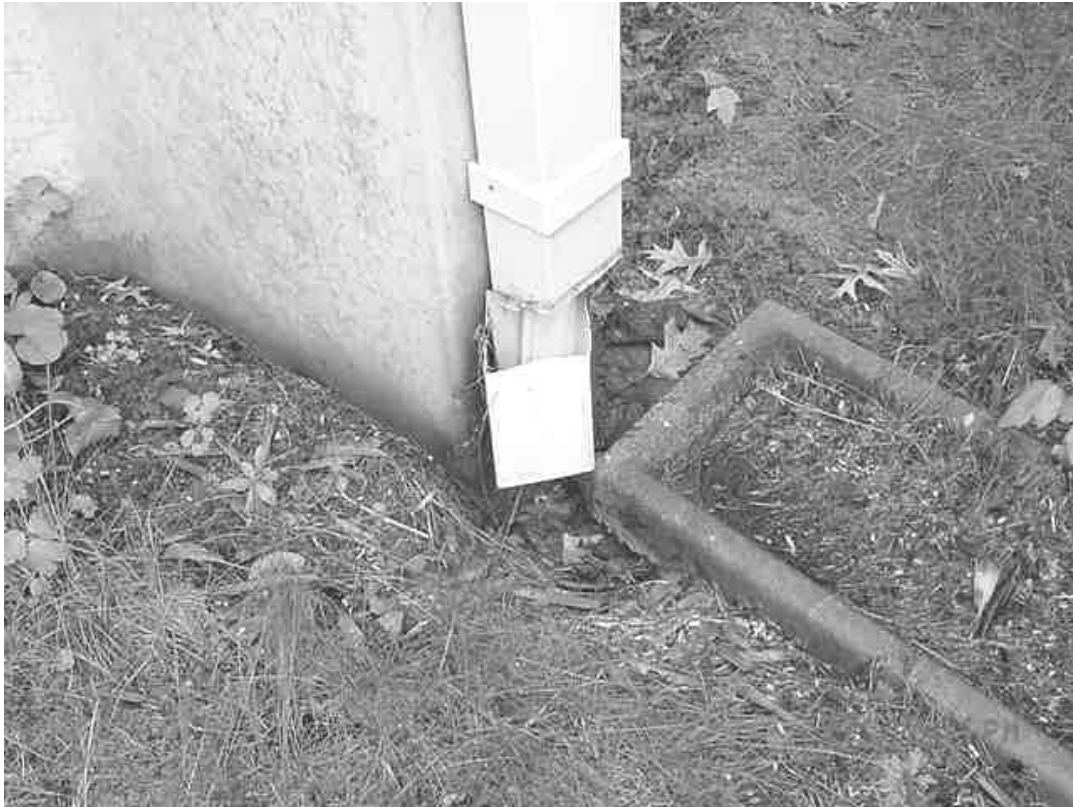
- Picture 13 shows a damaged downspout that empties rainwater against the foundation. In some cases catch basins were pitched toward the building, resulting in water pooling against the foundation (Picture 14).
- Piles of saturated plant debris were seen on the roof (Picture 15). This material can hold water on the roof where repeated freezing and thawing during winter months can damage the roof membrane and lead to water penetration.

Damaged Downspout Note Depression from Water Pooling Against Foundation

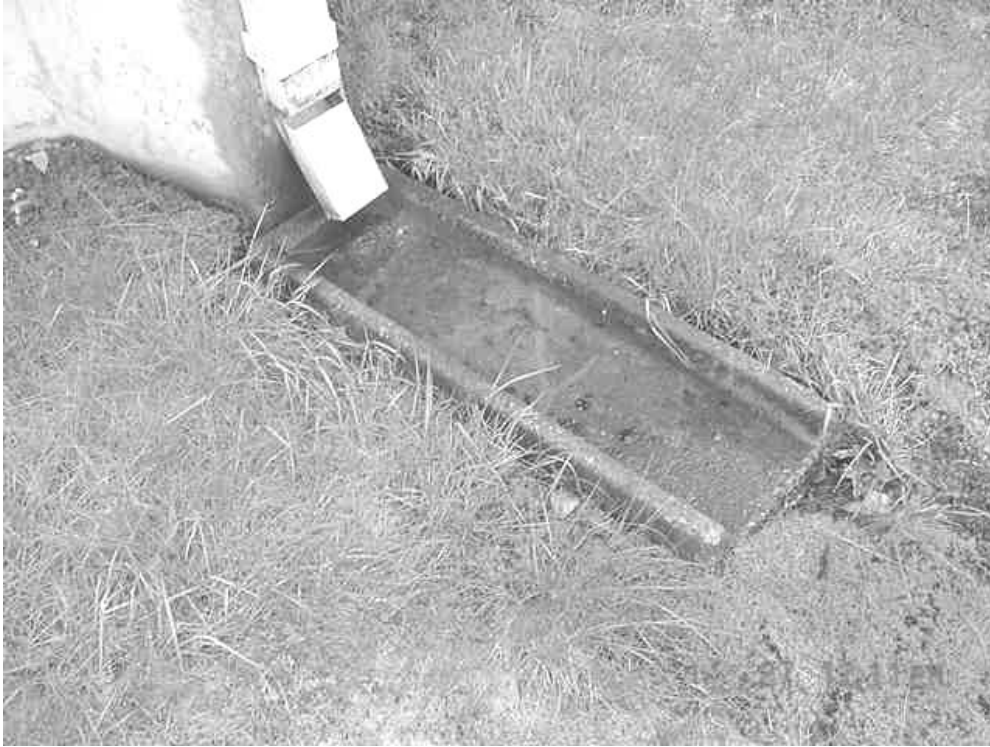
Picture 14

Downspout Catch Basin that was Pitched *Toward* Building

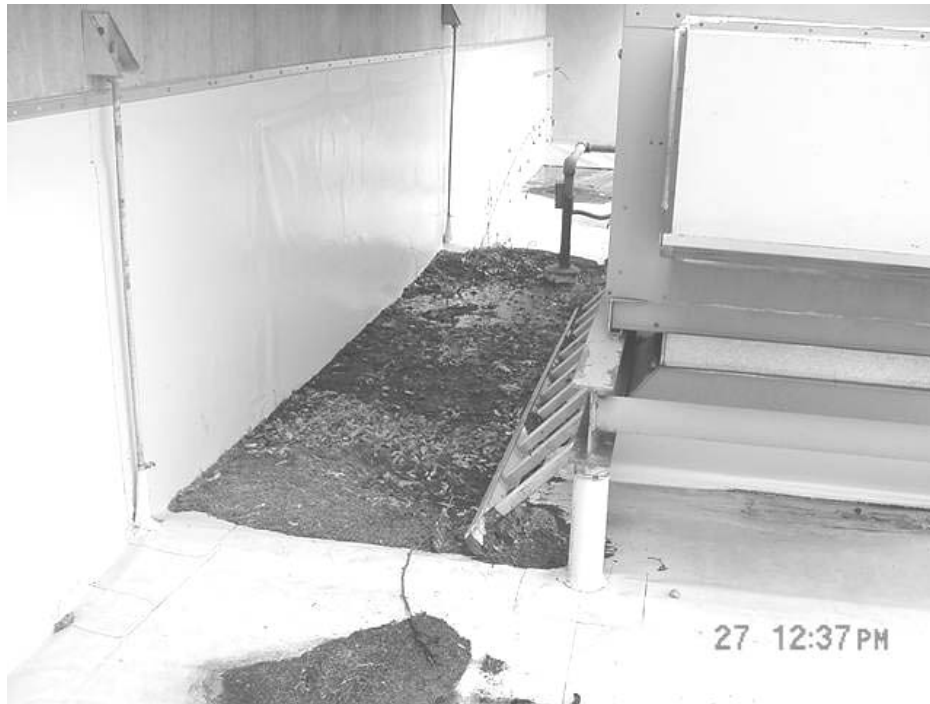
Picture 15

Large Pile of Plant Debris on Roof Against Wall

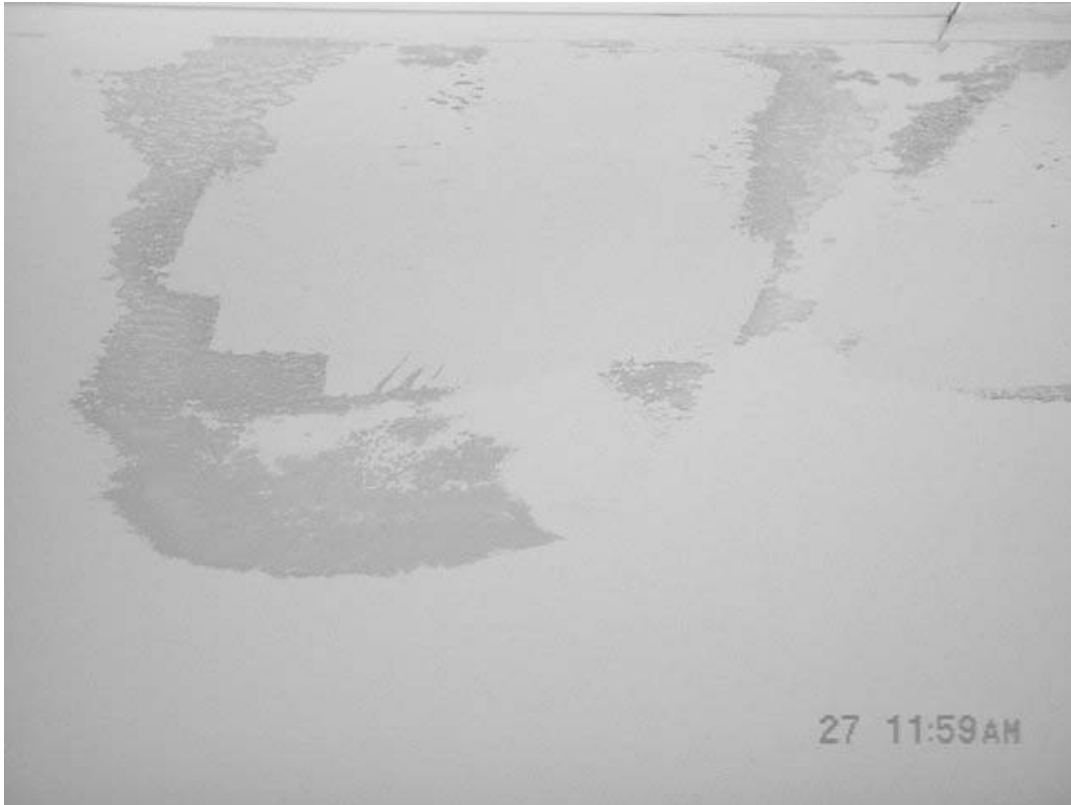
Picture 16

The ceiling in the small group room is made of gypsum wallboard (GW) and was water stained reportedly due to a roof leak that was repaired (Picture 16). In order for building materials to support mold growth, a source of water exposure is necessary. Identification and elimination of water moistening building materials is necessary to control mold growth. GW with increased moisture content over normal concentrations may indicate the possible presence of mold growth. Moisture testing of the water damaged GW in the small group room was tested and found to not be moistened. Microbial growth in GW in this area would be limited due to a lack of water.

Water Damaged GW Ceiling in Small Group Room

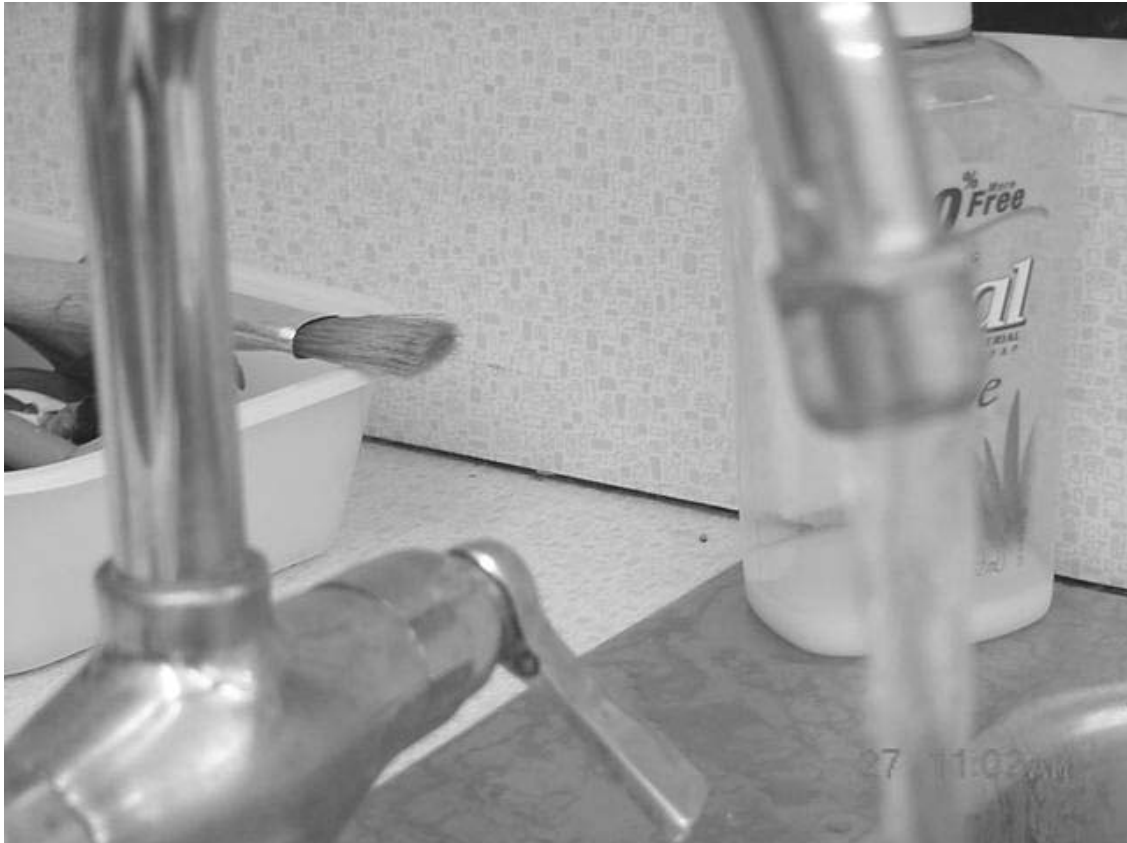
Picture 17

In a number of classrooms, spaces between the particleboard sink countertop and backsplash were noted (Picture 17). Improper drainage or sink overflow could lead to water penetration. If the seam is not watertight, water can collect behind countertops and/or cabinets. Like other porous materials, if wetted repeatedly they can provide a medium for mold growth.

Spaces Between Sink Countertop and Backsplash

13. Seal areas around sinks to prevent water-damage to the interior of cabinets and adjacent wallboard. Disinfect areas of microbial growth with an appropriate antimicrobial as needed. Consider replacing with one-piece, molded countertops.
